## Chemically-bonded enamel-coated steel pipelines for corrosion protection and flow efficiency

CHEMICALLY-BONDED ENAMEL-COATED STEEL PIPELINES FOR  
CORROSION PROTECTION AND FLOW EFFICIENCY

A DISSERTATION

CIVIL ENGINEERING

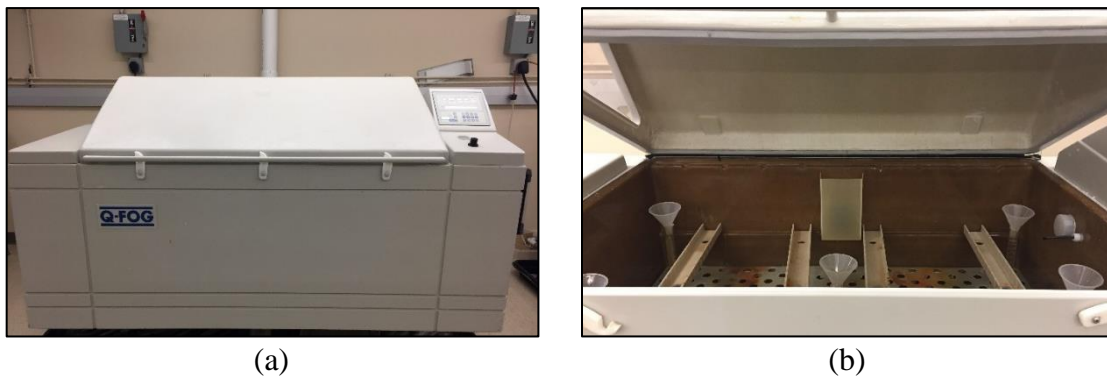
Figure 5.1. Salt spray chamber.
